#### STAINLESS STEEL BODY COMPARTMENT TOPS

The Sales Department would like to inform the dealer network that the following changes have been made to the SA75's, SL75's and SP70's aerial body. These units will now have 304 brushed stainless steel compartment tops as standard. Starting with HS-6176 the following surfaces have been updated.

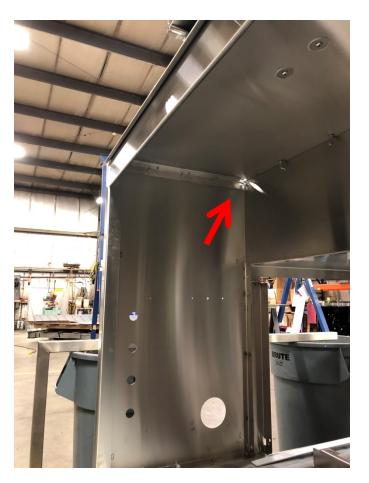
#### <u>DRIVER'S/OFFICER'S SIDE – REAR 2" x 2" STANCHION POSTS</u>

Sutphen has also improved the overall design of the driver's / officer's rear stanchion posts.

The stanchion no longer protrudes though the body thus reducing the risk for water penetration. The stanchion will be welding to angle, and bolted to the top of the body. The image on the right shows the interior of the compartment with a single hole for wiring to run up through the stanchion. This will help eliminate leak points at rear stanchion posts.
