SUTPHEN CORPORATION SALES TECHNICAL BULLETIN

A1 COMPARTMENT ROLL UP DOOR PAINT

STB-0027- A1 COMPARTMENT ROLL UP DOOR PAINT

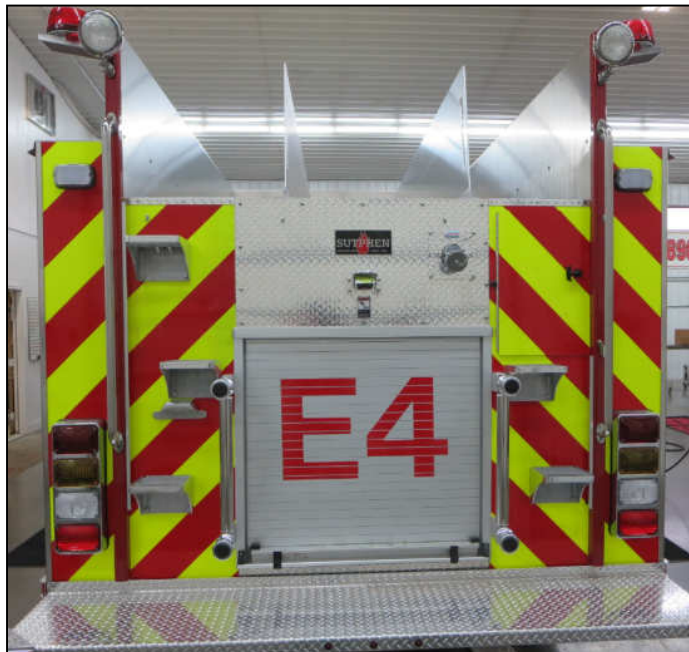
When roll up doors are selected to be painted the A1 compartment door remains satin finish (no paint). When hose couplings are being pulled out of the hose bed they tend to damage the painted doors. Also we have noticed that with many different shades of red paint they never matches the NFPA red chevrons. If customer wants the A1 door to be painted it will have to be specified and an additional charge will apply.
